S.F. Airport Roof Truss Erection

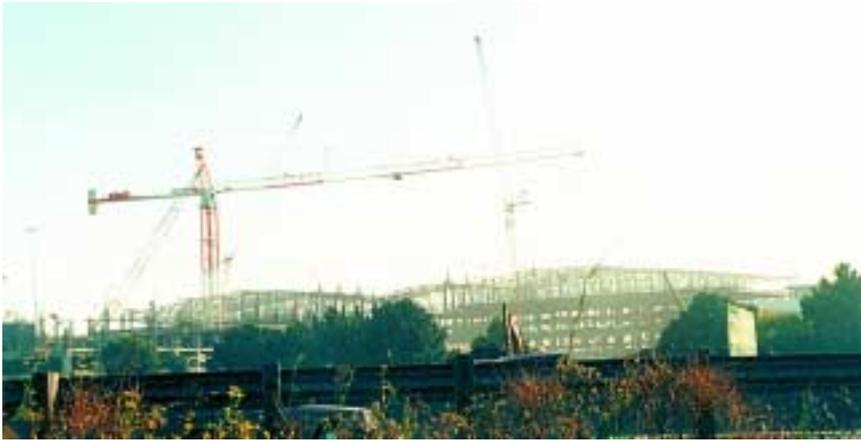
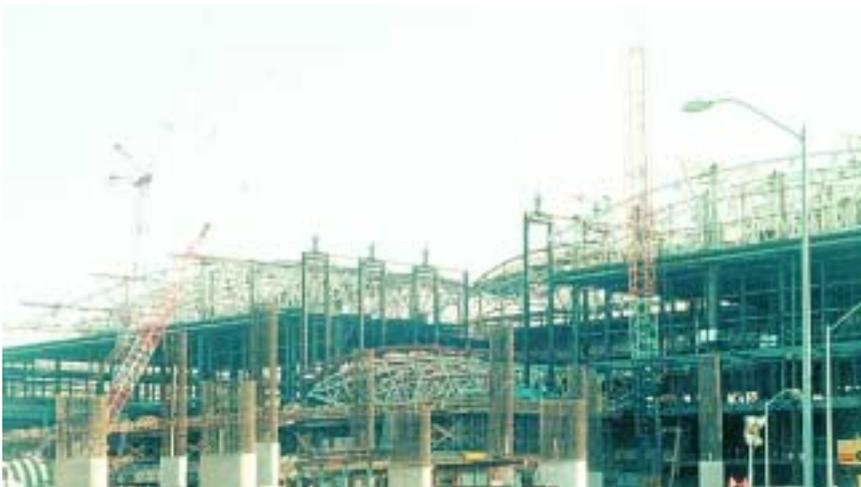
Double cantilever trusses support the center span three-chord "football" shaped trusses. The middle sections were erected first, followed by the outside cantilever and the inside cantilever trusses. Nylon Kevlar slings were used to cradle top chord pipe sections at designated pick points rather than welding lifting lugs to the API pipe and having to grind

them off. The support trusses rested atop two box columns. Special column splice erection aids were designed due to the height of the freestanding 46" box columns that support these trusses. A minimum column splice weld was also specified prior to erection of trusses in order to provide the required lateral strength. Stability during erection of trusses is always a concern. The connection between the truss and the box column is a ball and socket bearing structure; therefore, there was uncertainty as to the stiffness at the supports. The erector was directed to tie the trusses laterally at specified points prior to releasing them from the crane. This required the use of two cranes within the restricted work area.

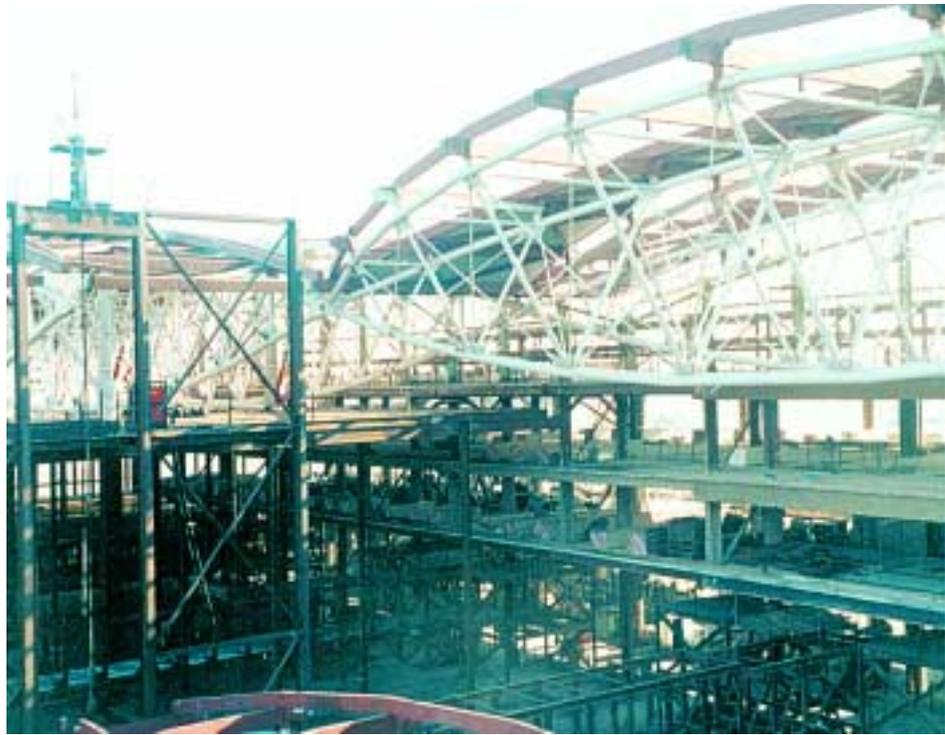
The jacks were positioned just inboard from the ends of the football trusses. This allowed the erector to use the nylon slings to cradle the bottom chord of the truss near the pin casting. Each jack lifted the trusses up using a 200-ton Hollow Ram Jack with a 4" diameter threaded rod. The rod sections were 20' long and were uncoupled and removed after passing through the jack. The hydraulic system was coupled to provide the same lifting rate at all four jacking points. Even with this precaution, each jacking point was continuously monitored and measured during the lift. Any time the differential exceeded 1", the individual jacks were adjusted.

The jacks required support platforms designed for 150 kips each at 80' above the working floor. These "jacking towers" consisted of W36 columns on each side of each jack. Struts and double angle bracing were framed between the columns for lateral strength and stability. A pinning platform was also built on the jacking towers for safe access during the pinning operation. The jacking towers were supported on the third floor steel. Some members were added and some permanent member sizes were changed in order to sustain the loads imparted by the lift. The entire erection procedure and design was submitted to the owner for review prior to beginning the operation.

The first lift of two trusses as well as the second lift of three trusses were completed and pinned without incident. The jacking took approximately 10 hours each lift. The tolerances were tight, but the pinning went smoothly, using a tapered lead pin attached to the permanent pin in order to mate the two members. Upon completion of each lift, the few remaining roof purlins were installed and the jacking towers removed.
